Common Ultrasound Probe Failures

As Seen in Clinical Settings

G. Wayne Moore, B.Sc., MA, FASE, FAIUM
Acertara Acoustic Laboratories

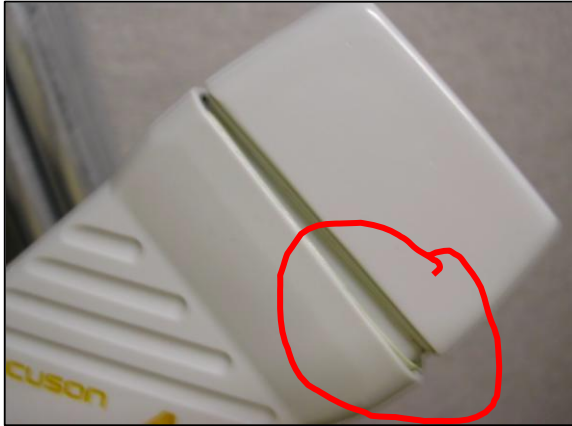
Array housing separating at the seam normally occurs when the probe has been in use for some time, or if there is a manufacturing defect. Many OEMs use glue in the manufacturing process to seal the cap of the array housing to the body of the probe. This glue can deteriorate as a function of time as well as from exposure to harsh cleaning agents. A probe with this failure should not be used as it may present an electrical shock hazard to the patient and the sonographer. Further, if cleaning agents get inside the probe they will normally destroy the array. This type of failure can be repaired if caught early.

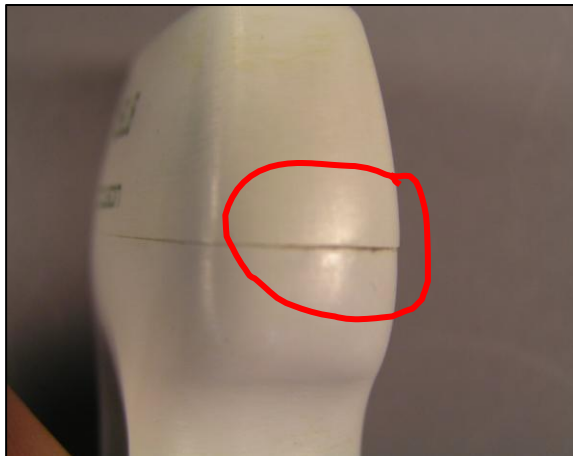
Seam line separating at the nose cone can become the site of fluid ingress. Less obvious than the example above, the probe to the left shows the beginning of the cap detachment. The compromise at the seam-line can be easily seen with the aid of a small magnifying glass (Loupe 10x). If the problem is found at this early stage, the probe is easily repairable.

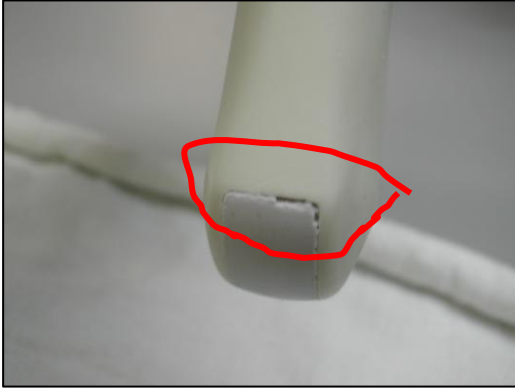
Lens separating from housing
Common Cause: Over cleaning and use of inappropriate cleaning agents.

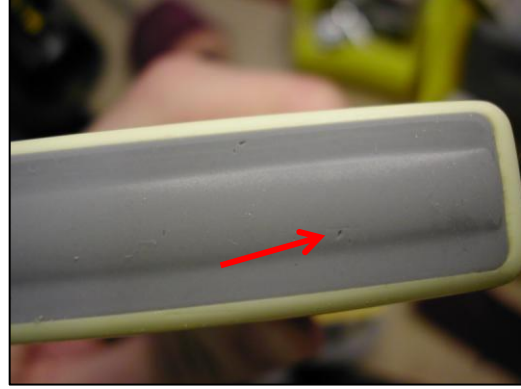
Multiple holes in the lens
Common Cause: Free-hand needle biopsy

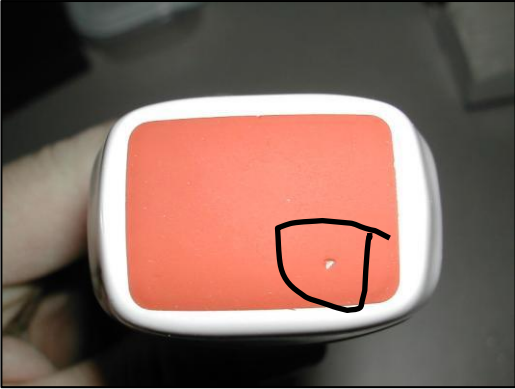
Hole in Lens
Common Cause: Rough cleaning

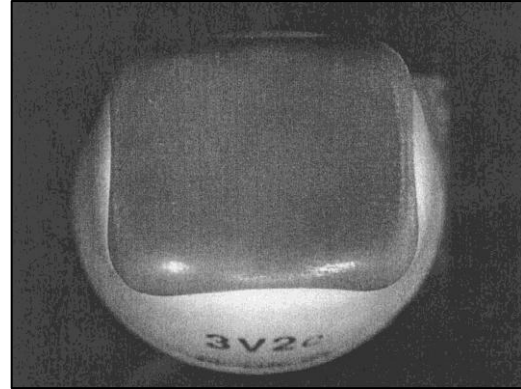
Swollen Lens
Common Cause: Manufacturing defect

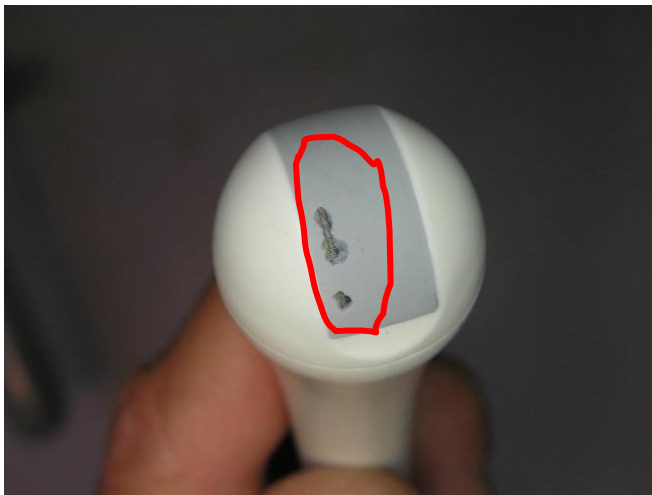
Multiple punctures
Common Causes: Trauma, improper HLD, or biopsy needles

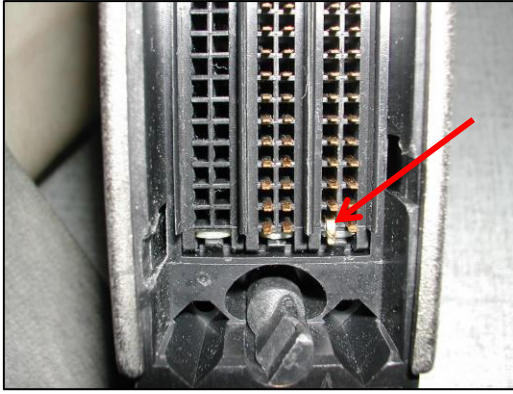
Bent pins in the connector

Common cause: Misalignment with system connector coupled with a hard shove

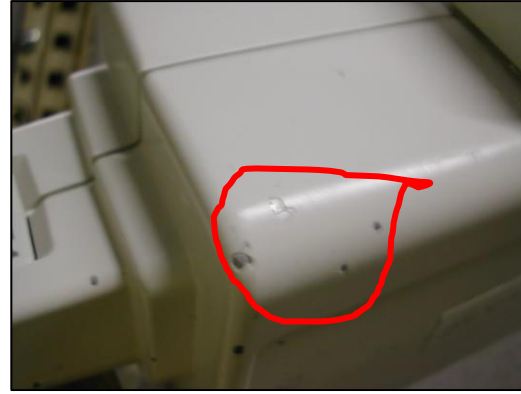
Dents in connector housing

Common cause: Rough use, trauma by dropping, or banging on a hard surface

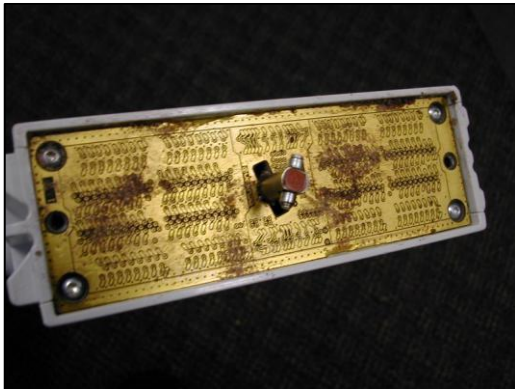
Dirty pin-less connector

Common cause: Poor or no preventive maintenance

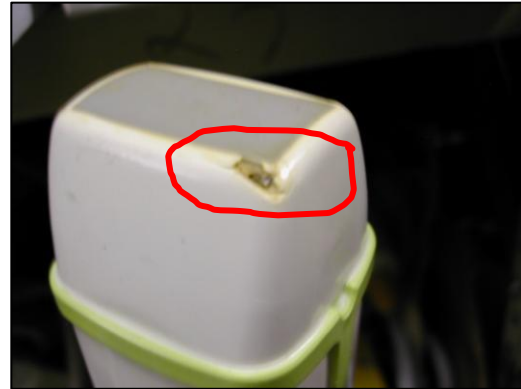
Crack in lens cap

Common cause: Dropping probe onto hard surface

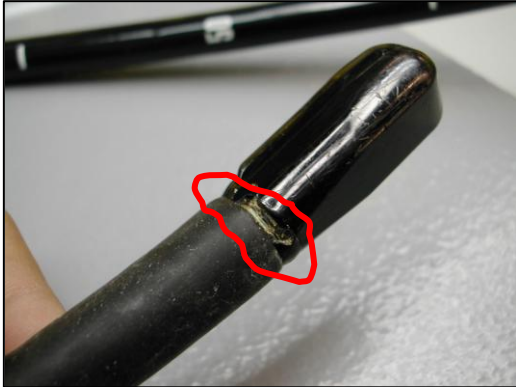
Broken seal near head of TEE probe
Common cause: Rough handling, poor storage, or aggressive cleaning

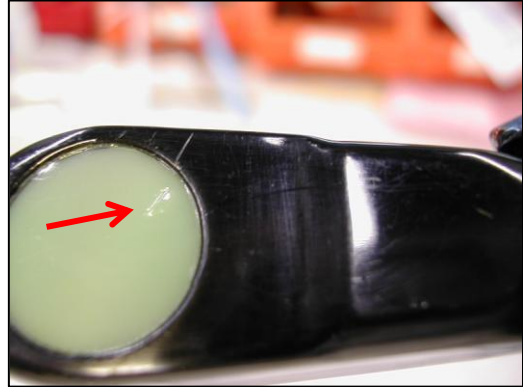
Scratch on TEE lens
Common cause: No bite guard, hard cleaning

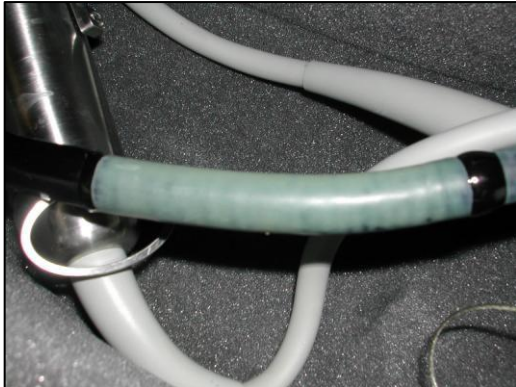
Contaminated bending rubber
Common Cause: over-soaking in Cidex

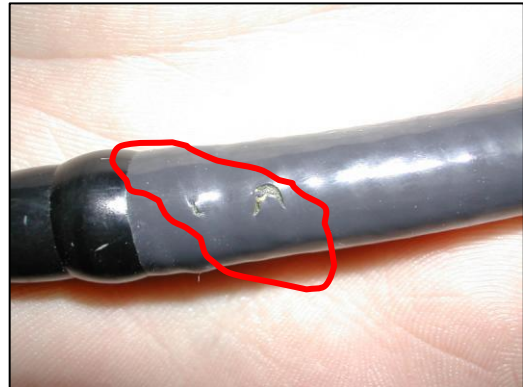
Holes in bending rubber
Common cause: Bite guard not used

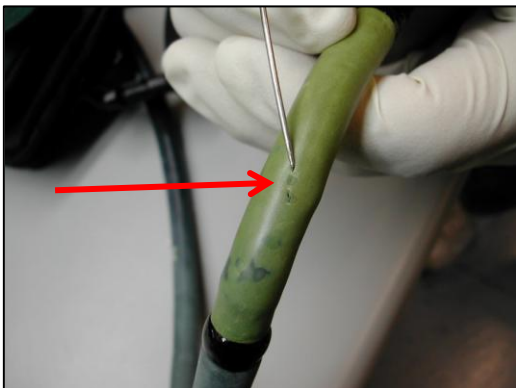
Stained bending rubber with hole
Common cause: Over-soaking and no bite guard

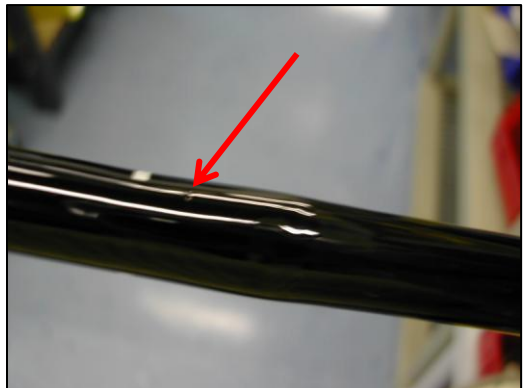
Bite mark in bending rubber
Common cause: Bite guard not used

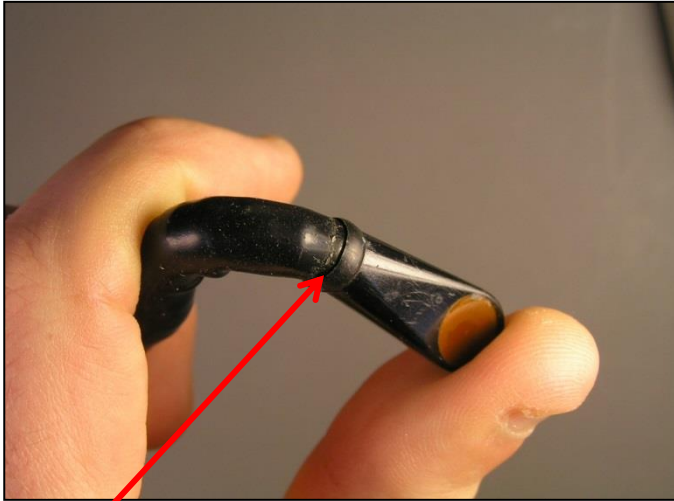
Bending Neck Bead split (also referred to as insertion tube sleeve)

Common cause: Age and multiple HLD cleanings, also improper storage or transportation

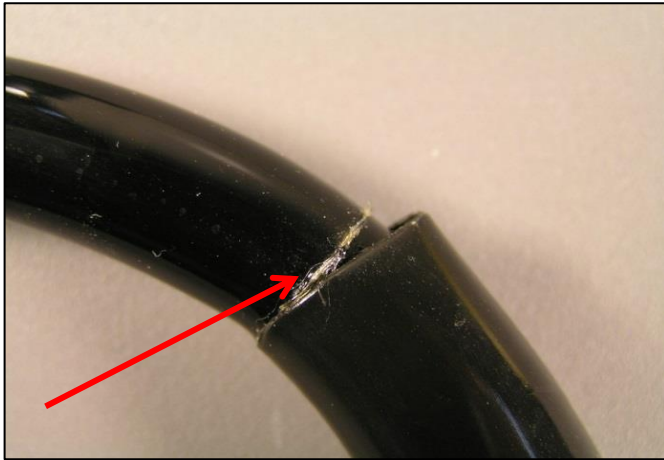
Damaged Insertion Tube (leads to fluid ingress and failing electrical leakage)

Common cause: Harsh cleaning over time, improper storage or transportation

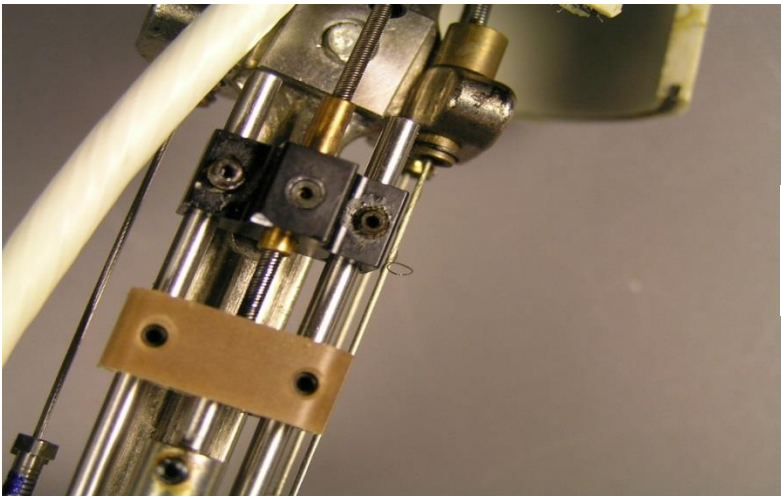
Corrosion on cable mounts
Common cause: Fluid ingress

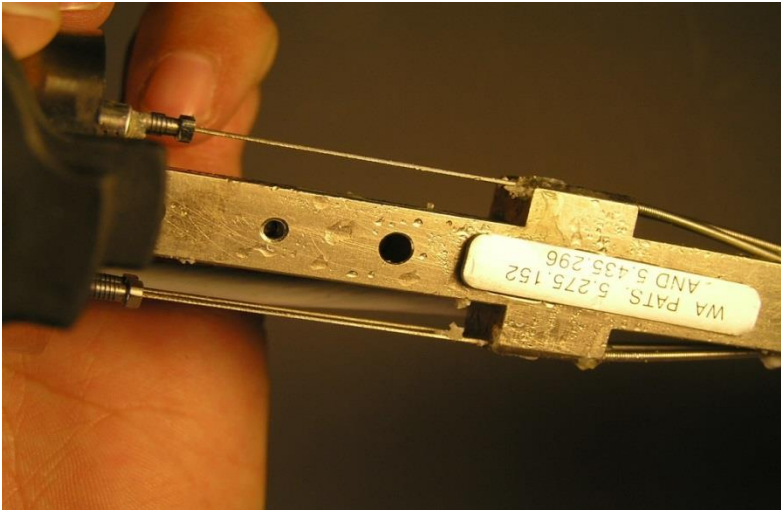
Frayed articulation wires
Common cause: Age and use

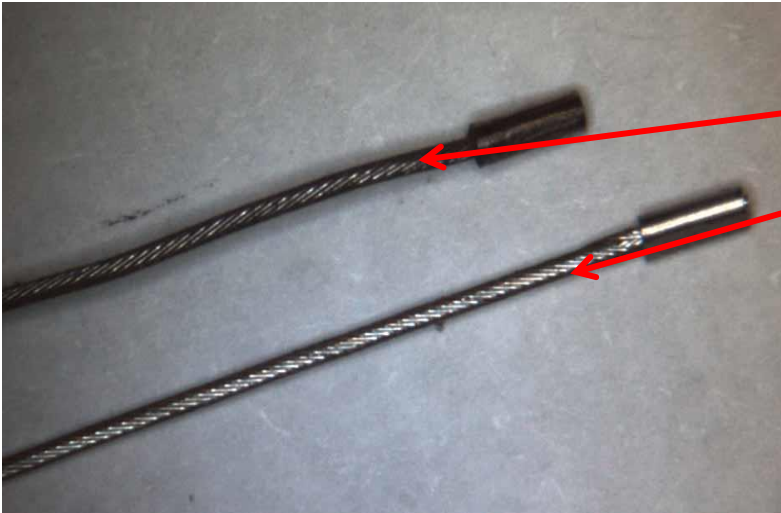
Corroded articulation wire
Common cause: Fluid ingress

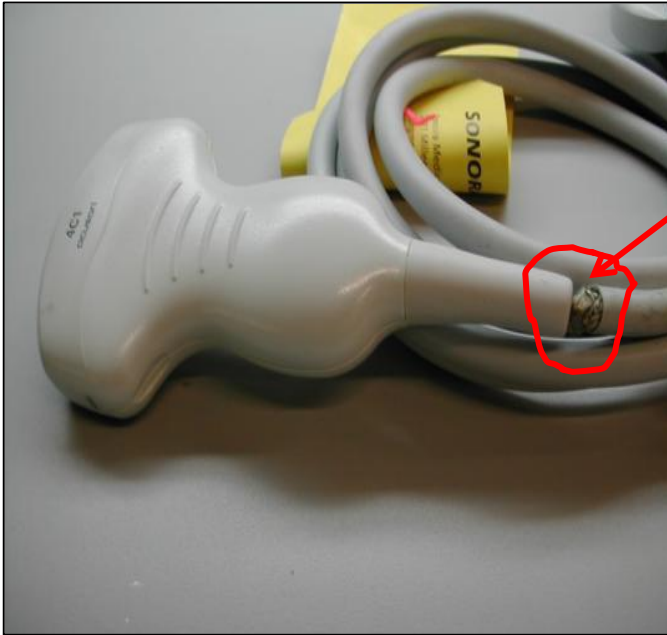
Cable pulled out from under strain
Common cause: Pulling the system by the probe

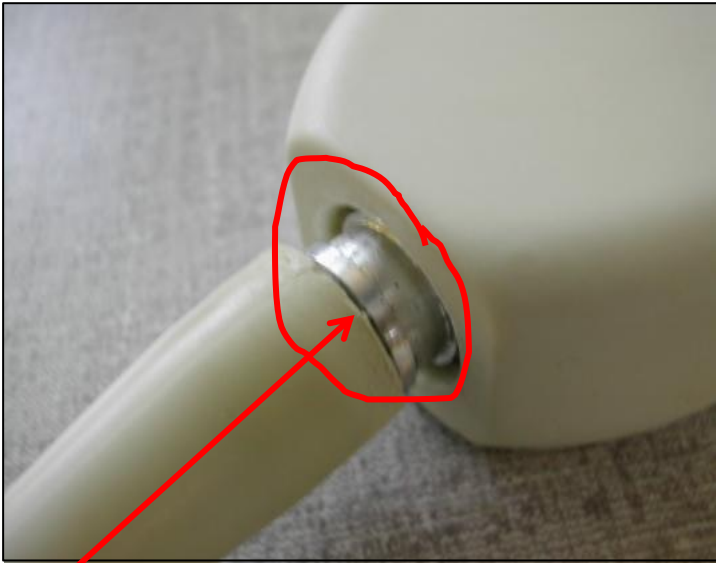
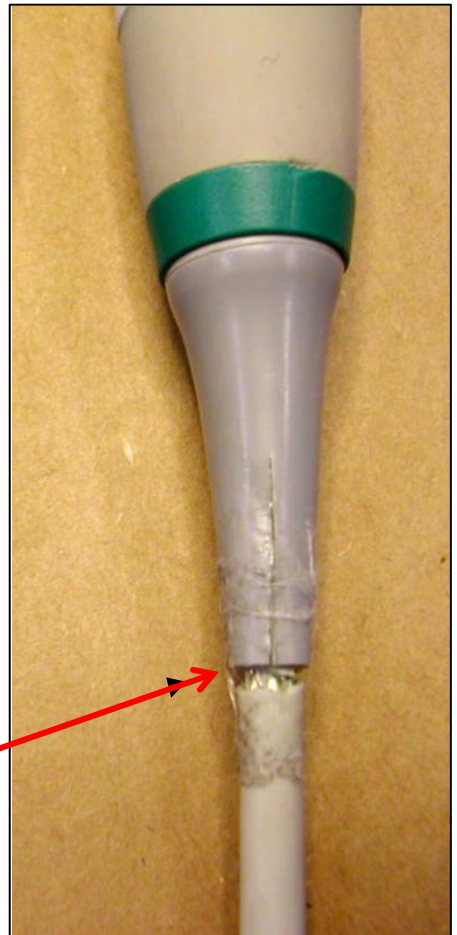
Strain relief pulling away from array housing

Common cause for both: User abuse

Cable pulled away from strain relief

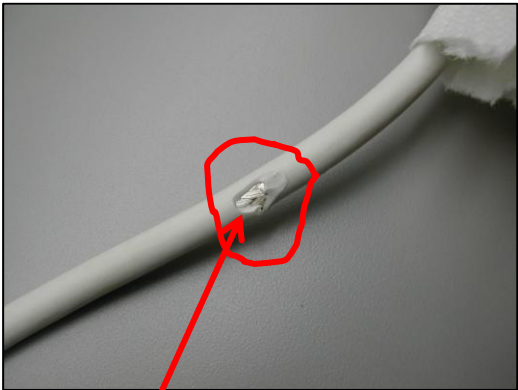
Cable Tear

Common cause: Cable catches in a doorway

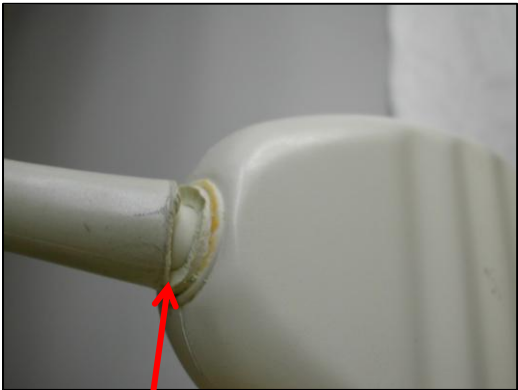
Strain Relief Tear

Common cause: Exertion trauma and decomposition

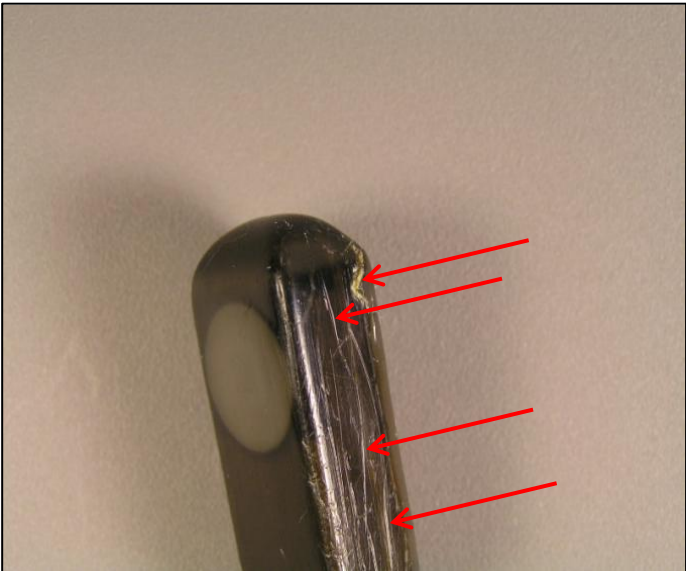
TEE Array Housing Scratches

Common cause: Cleaning station process

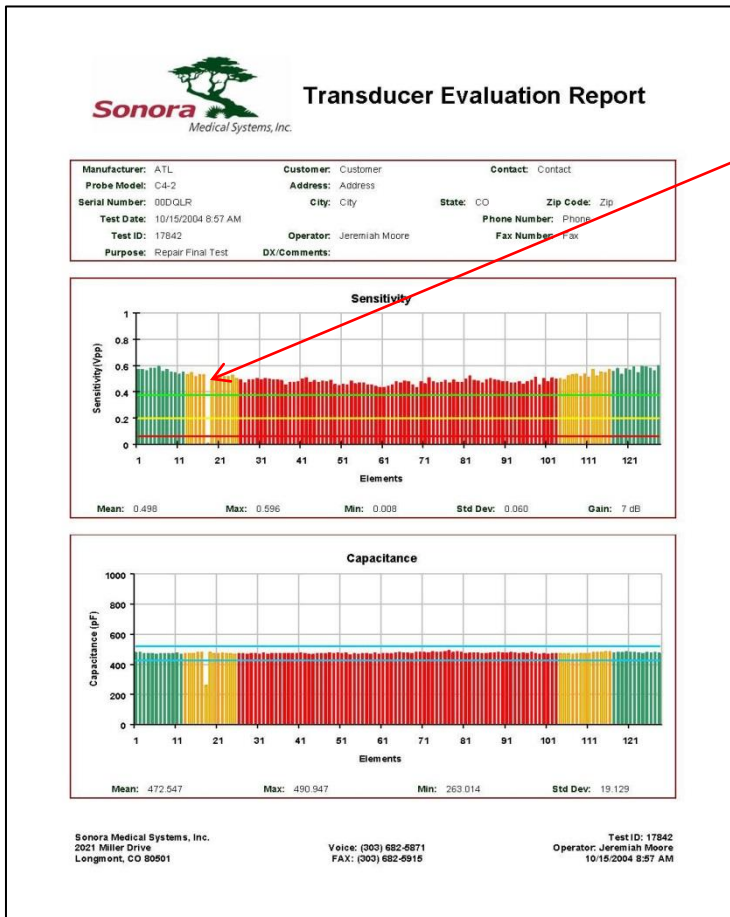
An example of a Sonora FirstCall Test Report, where each crystal within the array is tested, is shown below. In this example element number 19 is no longer functional (zero sensitivity). The FirstCall device was designed in the year 2000 and was introduced as a commercial product in 2001. FirstCall was designed by the current engineering team and Founders of Acertara. Although it remains a powerful tool for testing ultrasound probes, FirstCall requires an adaptor for each probe model (OEM). In 2014 there are so many different manufacturers and types of probes that a new type of probe tester was required. This new tester, Aureon, is shown on the following page. The color zones shown in the report relate to the level of importance of the elements within those zones being healthy. To understand the relationship between the numbers of elements within any given zone and the performance of the array please see the Acertara White Paper entitled “*Making Performance Calls on Contemporary Diagnostic Ultrasound Transducers*”

Single Dead Element

Common cause: Manufacturing process

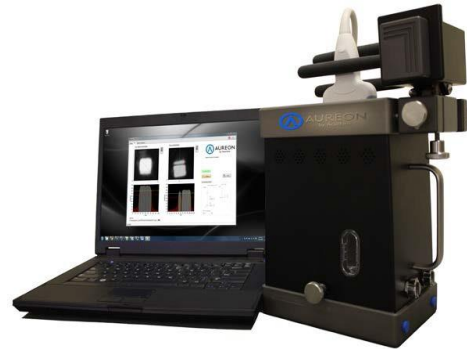
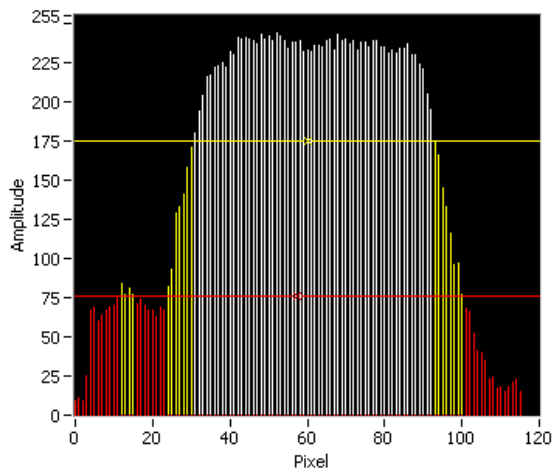
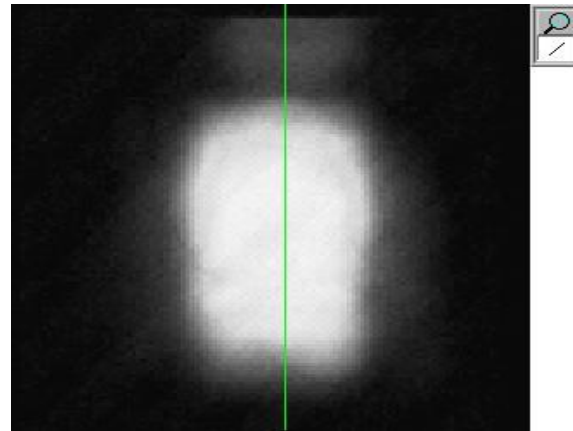
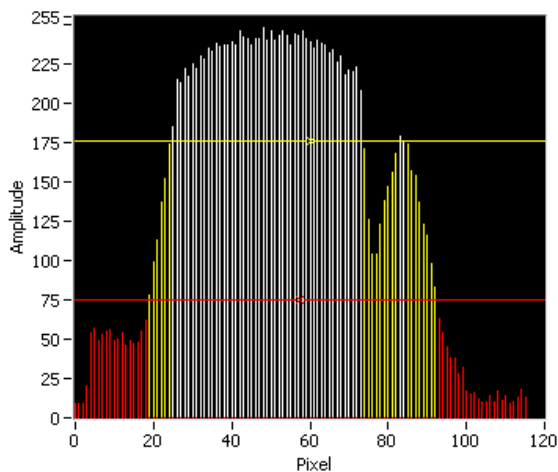
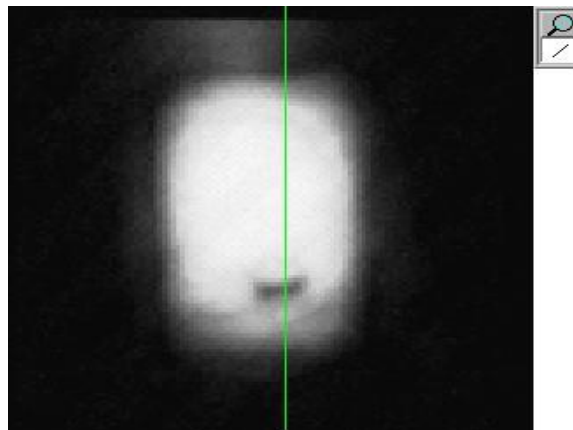
Shown in the Photo to the right is the new Aureon probe testing device from Acertara. This device is designed to be used with any probe and with any ultrasound system, without the need for an adaptor. Aureon captures, in real-time, the acoustic energy being emitted from the surface (aperture) of the probe under test. If there are any dead or weak elements the intensity of the image will either be subdued (weak element), or missing (dead element). This is demonstrated in the images below. The test shown is being performed on a Philips X6-1 matrix array probe that has more than 9,000 elements. A fully functional probe is shown in the top image and a less than functional probe, with two dead "zones" shown in the bottom image. The sonographer using the defective probe was complaining about a "strange" looking B-mode image, but could not determine what was causing it. The Aureon test revealed the two dead zones and the probe was taken out of service and returned to the OEM and replaced under warranty.

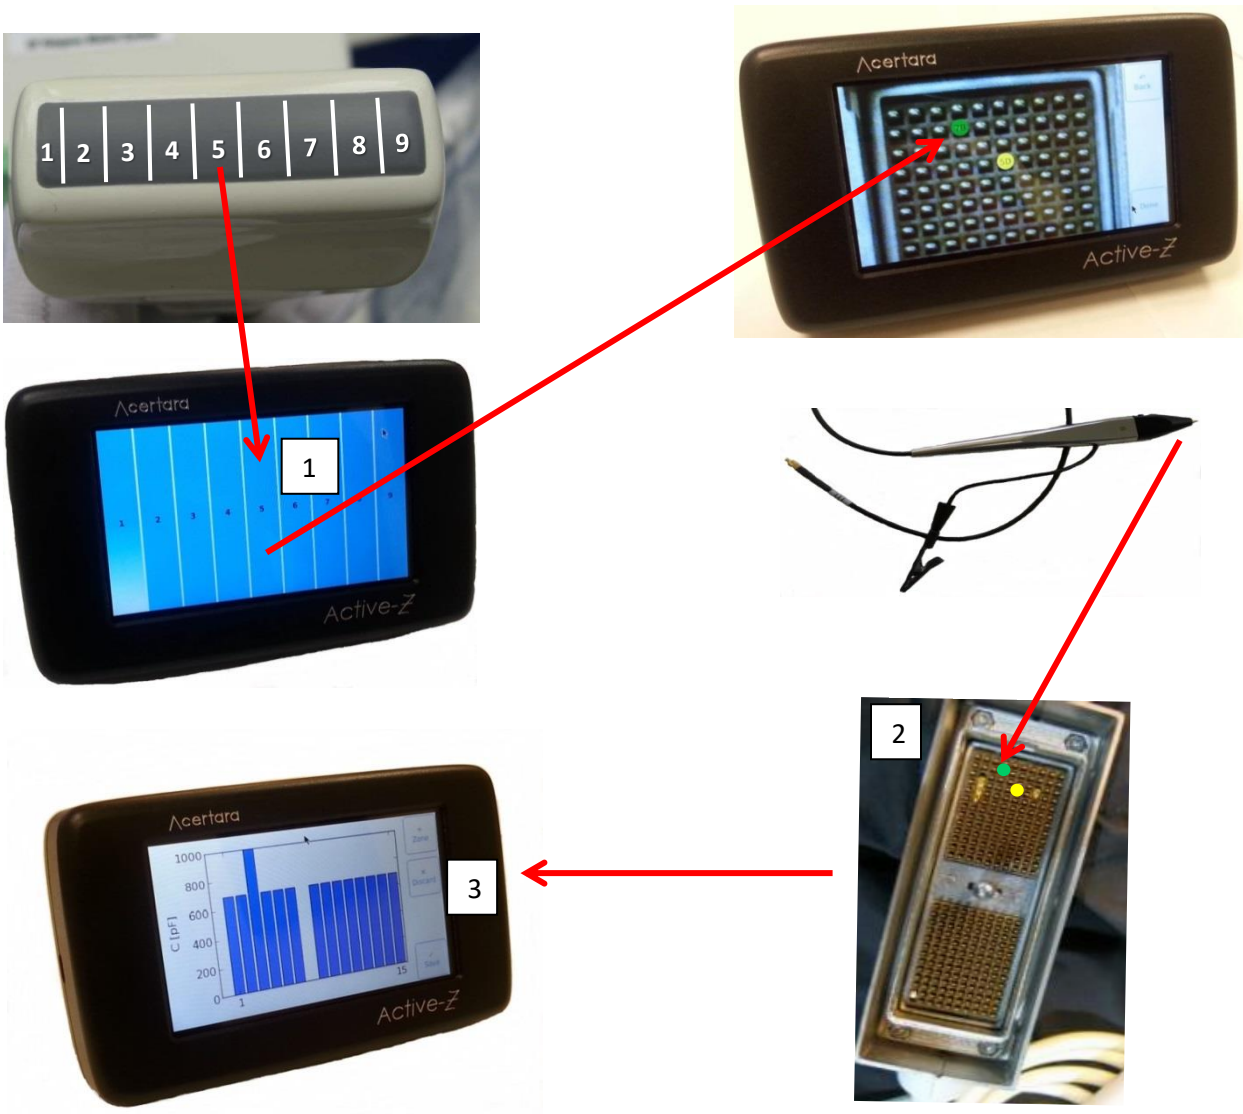
Active-Z™ is the industry standard for quantitatively testing the performance of diagnostic ultrasound transducers (probes). It is designed to be both easy to use and provide accurate and repeatable results concerning the health of the array, the cable, and the connector by measuring complex impedance. This low-cost, light-weight, point-of-test device features a rugged industrial design, long rechargeable battery life, USB connector for computer interface and report generation, and a high resolution LCD display. To use, simply touch the area of the probe's aperture, shown on the LCD display, where you suspect a problem may exist (1), use the Impedance probe to touch the corresponding pin in the connector (2), get immediate test results (3). There are normally ~ 15 elements per sub-aperture. The test below show element number 7 is dead, and a capacitive short in element number 3
