Ensuring Clinical Efficacy and Patient Safety With Repaired Ultrasound Probes

Timothy A. Bigelow, PhD, G. Wayne Moore, BSc, MA, James A. Zagzebski, PhD

From the Center for Nondestructive Evaluation, Iowa State University, Ames, Iowa USA (T.A.B.); Acertara Acoustic Laboratories, Longmont, Colorado USA (G.W.M.); and Department of Medical Physics, University of Wisconsin, Madison, Wisconsin USA (J.A.Z.).

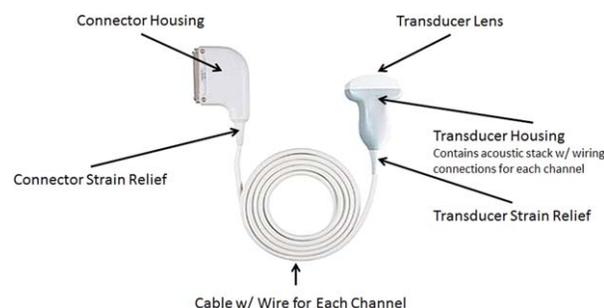
Figure 1. Review of probe nomenclature for a standard probe.

The configuration for a standard general imaging probe is shown in Figure 1, and a TEE probe is shown in Figure 2. Notable in each example is a connector that allows bidirectional transmission of electrical signals between the probe and ultrasound imaging system. The connection is needed to provide power and acoustic signal paths to the acoustic stack, consisting of the piezoelectric elements and their backing and matching layers. The connection must support precise phase control of the transferred signals. The acoustic stack is protected

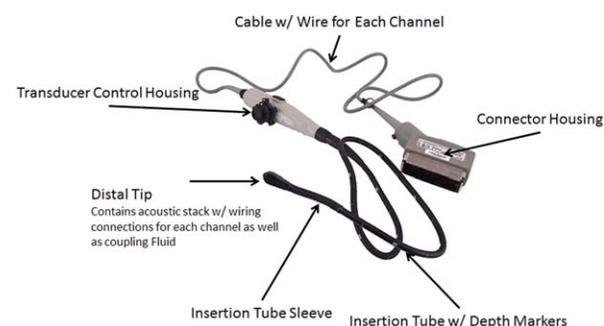
Figure 2. Review of probe nomenclature for a TEE probe.

and stabilized within the transducer housing (standard probe) or distal tip (TEE probe). It must provide precise positioning relative to the transducer lens. Some probes, such as those used for 3/4-dimensional fetal imaging (ie, wobblers) and TEE probes, also contain coupling fluid in the transducer housing/distal tip. In addition to providing electrical isolation from the patient, the lens on a standard probe can provide additional wave front shaping to achieve the desired ultrasound beam profile in the elevational direction, and it provides protection for the acoustic stack.

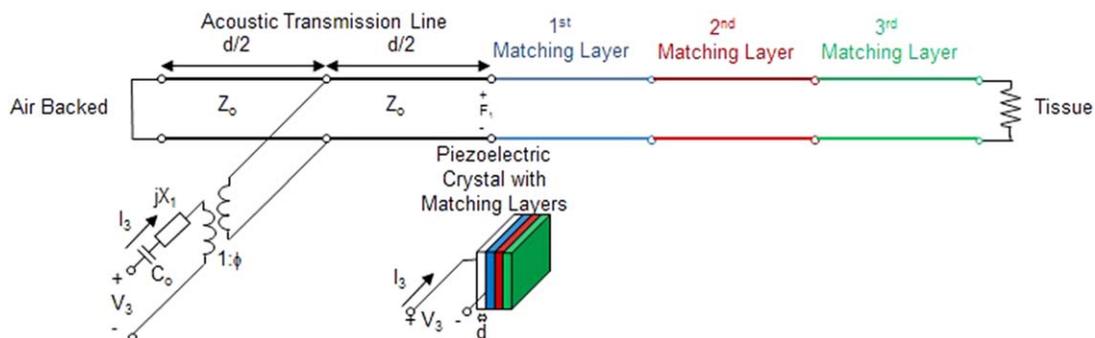
Figure 3. KLM model with 3 matching layers for our illustrative example.

In this model, V_3 and I_3 are the respective voltage and current applied to the piezoelectric crystal, which produces the resulting acoustic forces and particle velocities at the faces of the crystal. The model parameters include the thickness of the crystal, d , the area of the

crystal, A , and the characteristic impedance of the acoustic transmission line (ie, the radiation impedance) modeling the piezoelectric crystal, Z_o . To complete the model, it is also necessary to include a capacitor, C_o , impedance, jX_1 , and a transformer with the ratio $(1:\phi)$ that converts the electrical signal into the appropriate acoustical values. C_o results from the resonator consisting of a dielectric, the piezoelectric crystal, between 2 excited conducting surfaces. The values for these parameters are given by

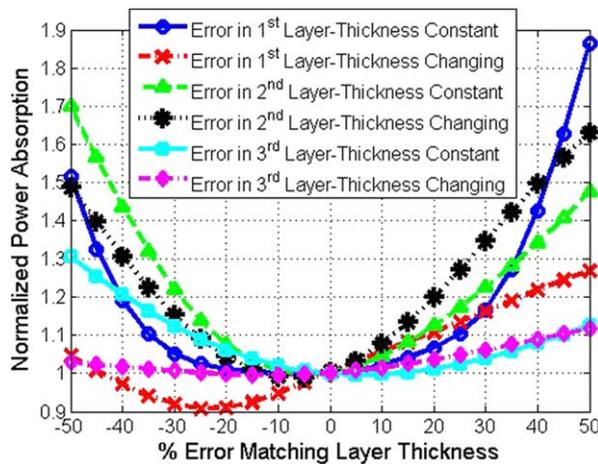
Figure 4. Normalized power absorption relative to the optimal case as a function of the error in the corresponding matching layer thickness. The results for both constant acoustic stack thickness and variable acoustic stack thickness are shown.

The results for the first set of simulations are shown in Figures 4–6. In each of these figures, the horizontal axis is the percent error in the matching layer thickness, whereas the vertical axis is the normalized values for power absorption, the pulse duration, and the output

Focusing on the second layer, errors in layer thickness on the order of 20% to 30% (only 40–60 μm) result in a 20% to 35% increase in power absorption by the matching layer material. Therefore, if under normal conditions a standard imaging probe was warmed from room temperature (≈22°C) to approximately 40°C, the repaired probe could have approximately a 20% to 35% higher increase in temperature, bringing it to approximately 45°C. This temperature is beyond the safety limit and has the potential to burn the patient. In addition,

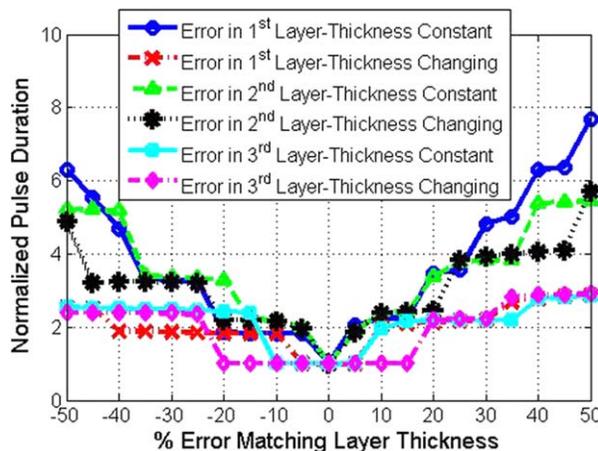
Figure 5. Normalized pulse duration relative to the optimal case as a function of the error in the corresponding matching layer thickness. The results for both constant acoustic stack thickness and variable acoustic stack thickness are shown.

peak-peak pressure amplitude, respectively. The step changes in Figure 5 are expected on the basis of our definition of pulse duration. If you recall, the pulse duration was set as the time during which the amplitude of the pulse was equal to or greater than 10% of its maximum value. Therefore, the pulse duration will jump by approximately half of the wave period as subsequent acoustic cycles increase in amplitude with the degradation of probe performance. From these figures, it is clear that errors in the thickness of the second matching layer consistently result in the largest degradation in probe performance and safety. The degradation that occurs due to errors in the first layer thickness when the overall thickness is kept constant is likely an artifact caused by the constant-thickness constraint due to the change in the second-layer thickness to compensate for the changes in the first-layer thickness. Recall that the constant-thickness scenario required the second and third layers to change along with the first layer so that the overall thickness remained the same.

errors in the second-layer thickness of 20% to 30% will result in a 4-fold increase in the pulse duration. Since the pulse duration is directly related to the axial resolution in the imaging system, a 4-fold increase in the pulse duration corresponds approximately to 4 times poorer axial resolution for the imaging system. Therefore, the reduction in image quality with errors in probe repair is even more pronounced than the potential safety concerns. Last, there is some decrease in the peak-peak pressure amplitude with errors in layer thickness. Since the peak-peak pressure amplitude values only decrease under the

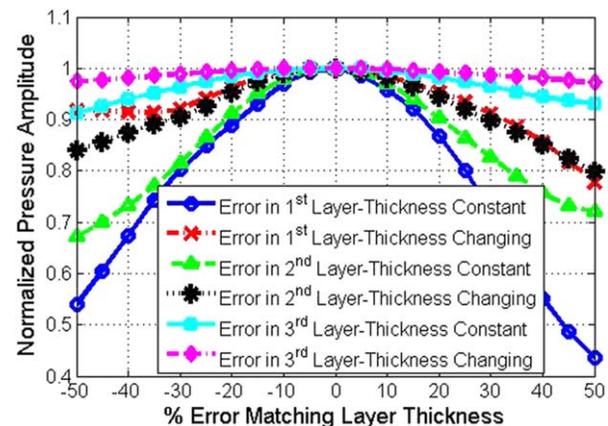
Figure 6. Normalized peak-peak pressure amplitude relative to the optimal case as a function of the error in the corresponding matching layer thickness. The results for both constant acoustic stack thickness and variable acoustic stack thickness are shown.

limitations of the simulation parameters considered in this example, the field values are not anticipated to exceed the FDA level of 720 mW/cm^2 . However, the reduction in pressure amplitudes would mean a loss of sensitivity and a loss of imaging depth for the probe.

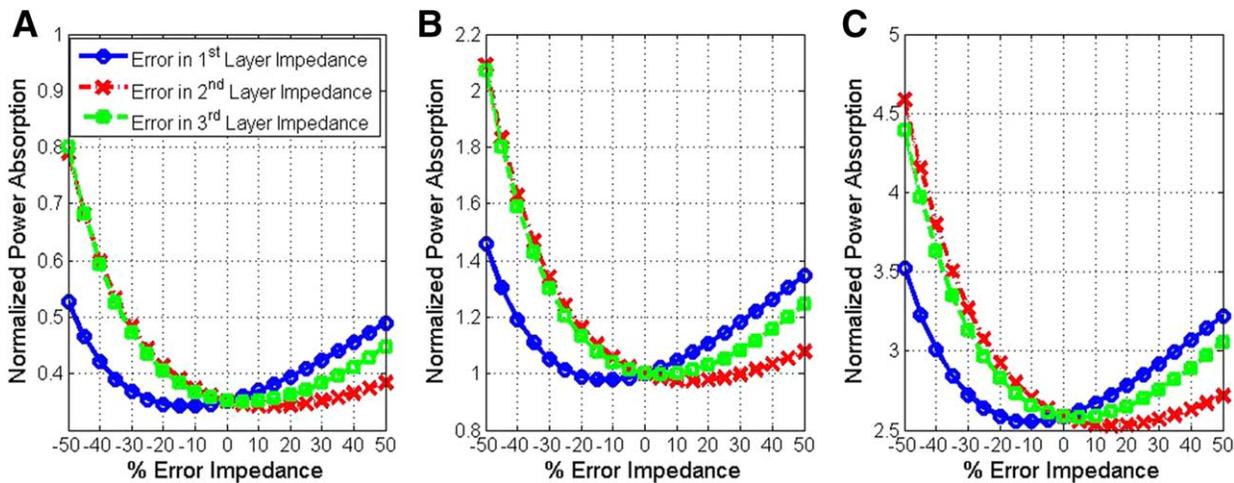
Figure 7. Normalized power absorption relative to the optimal case as a function of the error in the corresponding matching layer impedance for acoustic stack attenuations of 0.25 (A), 0.75 (B), and 2.25 (C) dB/cm-MHz.

The results for the second set of simulations are shown in Figures 7–9. For these results, the thicknesses were assumed to be the same as the optimal probe configuration, but the acoustic impedance of the layers and attenuation of the acoustic stack were varied. From Figure 7, it is clear that changes in the attenuation of the

acoustic stack dramatically affect the power absorbed within it; consequently, probe heating as the power is absorbed is 2.5 to 4 times higher for the more-attenuating material. Therefore, if a probe repair facility selects a lossy substitute layer material, probe heating can be dramatically higher than it was in the original OEM configuration. This factor is especially a concern for some epoxy composites, given their higher attenuation values. Errors in matching layer impedance are much less substantial but can still result in dramatically increased heating for large impedance mismatches. For example, a 30% drop in impedance can result in a 30% increase in power absorbed.

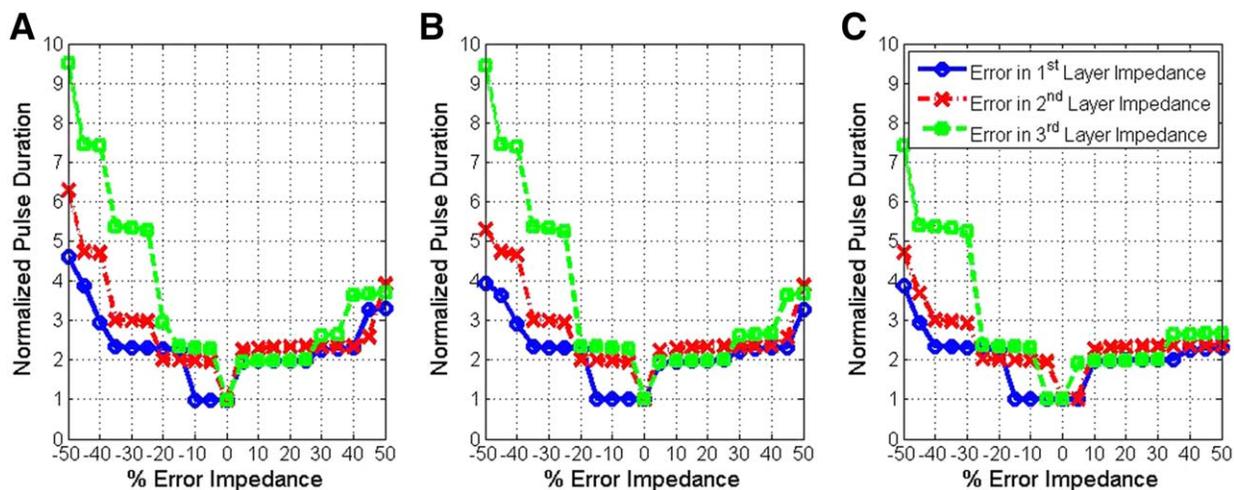
Figure 8. Normalized pulse duration relative to the optimal case as a function of the error in the corresponding matching layer impedance for acoustic stack attenuations of 0.25 (A), 0.75 (B), and 2.25 (C) dB/cm-MHz.

Figures 8 and 9 show that changes in attenuation have a relatively minimal impact on the pulse duration and the peak-peak pressure amplitude. Therefore, changes in image quality and sensitivity would not be clearly identifiable if the only deviation in material properties were the attenuation. However, substantial changes in attenuation would likely be accompanied by changes in acoustic impedance, which would result in poor spatial resolution (Figure 8) and a reduction in imaging sensitivity (Figure 9). For example, a 30% drop in impedance would give more than a factor of 5 increase in the pulse duration (Figure 8), resulting in a factor of 5 loss in image resolution as well as a 10% loss in pressure amplitude (Figure 9). The lack of dependence of the peak-peak pressure amplitude on attenuation is likely due to the relative thinness of the layers.

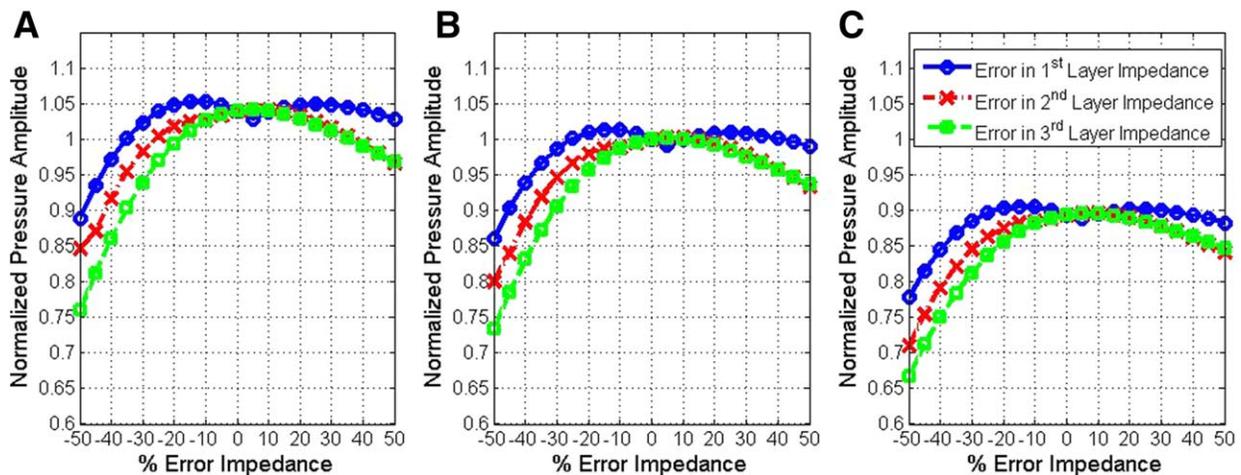
Figure 9. Normalized peak-peak pressure amplitude relative to the optimal case as a function of the error in the corresponding matching layer impedance for acoustic stack attenuations of 0.25 (A), 0.75 (B), and 2.25 (C) dB/cm-MHz.

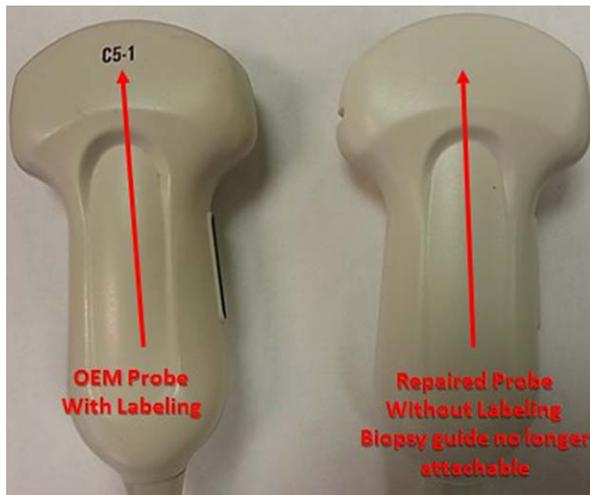
Figure 10. Original OEM probe next to a poor-quality repaired probe. The repaired probe had only 63% sensitivity relative to the original probe, was not properly labeled, and had a new case that did not allow the biopsy guide to be used.

Now that our simulations have illustrated how relatively small changes in probe construction can have a dramatic impact on ultrasound image quality and probe heating, consider some examples of actual poor-quality probe repairs. To begin, consider a third-party repaired probe in which the OEM acoustic stack was replaced with an array made by a third-party manufacturer. Also, a new transducer housing was used that had no label and, because of improper fit and design, no longer allowed the original biopsy guide to be used (Figure 10). This change could potentially create a substantial hazard to the patient, as a misregistered biopsy guide could result in sampling of the wrong tissue for biopsy, which could result in a wrong diagnosis as well as damage to sensitive tissue structures.

In addition to noting the new housing, the sensitivity of the non-OEM array was assessed with an electronic transducer tester (FirstCall; Acertara Acoustic Laboratories, Longmont, CO), which measured the echo amplitude from a reflecting surface for each element. The results shown in Figure 11 indicate that the sensitivity response was only 63% of that of the OEM array. The sonographers reported that this probe produced non-diagnostic-quality images, and they ceased using it.

probe did not fit in the original case, it is very likely that the repaired probe had errors in layer thicknesses of 50% or greater. Therefore, it is likely that in addition to poor sensitivity, this probe would have poor imaging

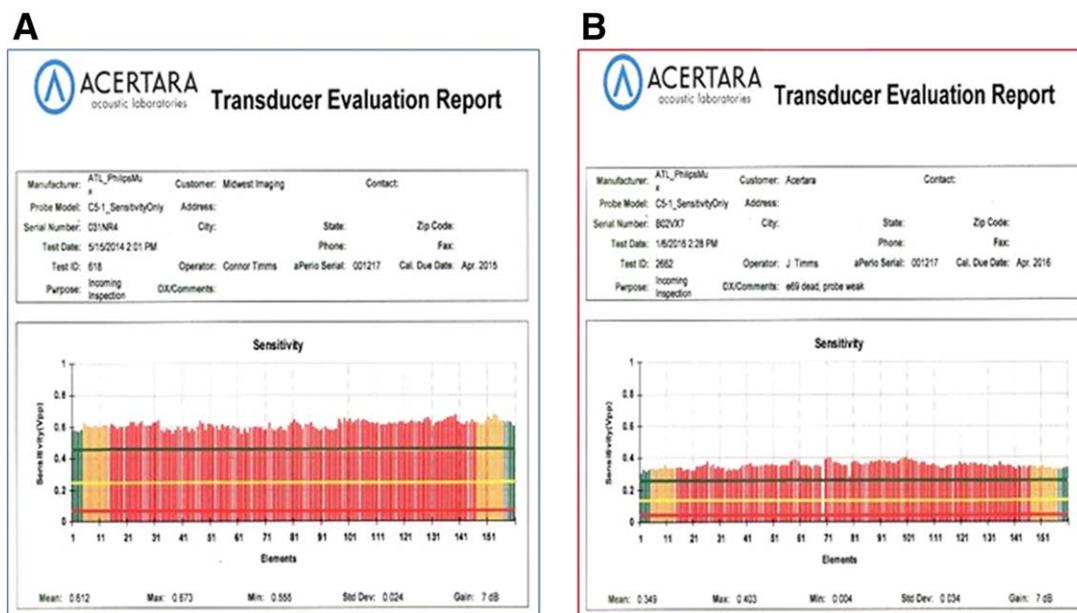
Figure 11. Sensitivity comparison of an original OEM probe (A) and a poorly repaired probe (B). Sensitivity is defined as the echo signal amplitude (volts peak-peak) produced by each element in the array for a smooth reflecting interface.

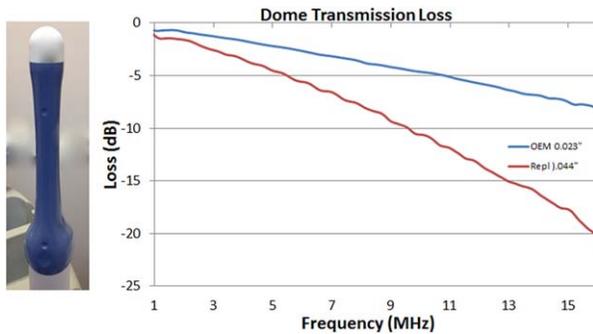
Figure 12. Dome transmission loss comparison between an original OEM probe dome (blue line) and a non-OEM dome used in a repair (red line).

Another poorly repaired probe example is shown in Figure 12 for an endocavitary transducer. The white dome (shown on the left) was replaced with a non-OEM part, and the new configuration had dramatically different signal attenuation losses from the original, ranging from 1 dB at 1 MHz to 20 dB at 15 MHz. This non-OEM replacement dome was tested for 1-way transmission loss using time delay spectrometry on an ARTIS time delay spectrometry system (Acertara Acoustic Laboratories)¹⁸ and compared to the transmission loss of an OEM dome. In clinical use, these losses are 2 way, transmit and receive, and substantially affect the clinical utility of the probe, with loss of the depth of penetration. Changes in probe material attenuation (ie, insertion loss) can also result in substantial increases in probe heating, as demonstrated by our simulations.

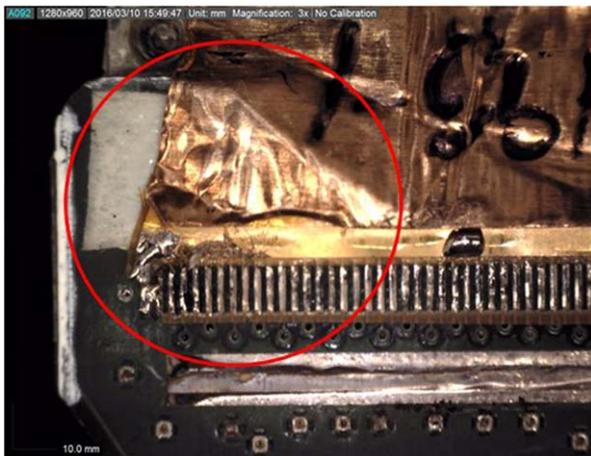
Figure 13. Poor-quality termination repair that resulted in signal dropout and increased speckle noise.

In addition to the third-party repair company's obvious lack of a quality control system, as demonstrated by a nonvalidated, non-OEM acoustic stack and the presence of probe materials that affect acoustic transmission, poor-quality repairs can also be evidenced by the lack of high-quality workmanship. For example, Figure 13 shows an example of a third-party flex circuit retermination repair at the acoustic stack, where thick solder

joints and electrical tape are found. When the clinical user received this repaired probe back, signal dropout and speckle noise were immediately noticed in the B-mode image and on color flow Doppler imaging compared to results from an identical OEM transducer. The probe was sent to an acoustics laboratory for forensic evaluation, and tests revealed the very poor retermination attempt.

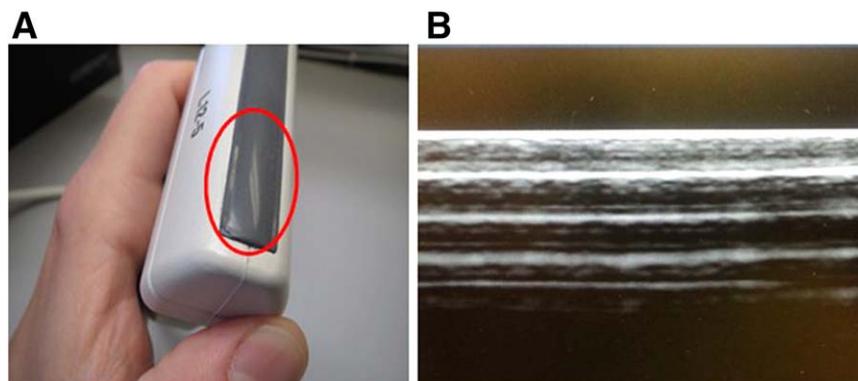
Figure 14. Improper layering of the lens material (A) resulting a tilt in the image, multiple reverberations (B), and unacceptable image quality.

Figure 14 shows another example of a repaired probe episode, in which material used to form a replacement lens was not evenly layered across the face of the transducer (one end of the lens was more than twice as thick as the opposite side). This repair resulted in a tilt in the image, multiple reverberations (Figure 14B), and unacceptable image quality. Figure 15 shows another example of a 2-dimensional array transducer (X5-1; Philips Healthcare, Bothell, WA), which was returned to Philips because of poor performance. The lens material had been replaced, as had the strain release between the cable and probe, which had cracked. A piece of the handle had also cracked, probably when the nose of the probe was removed during the repair. The nose was also poorly glued back on with a large gap.

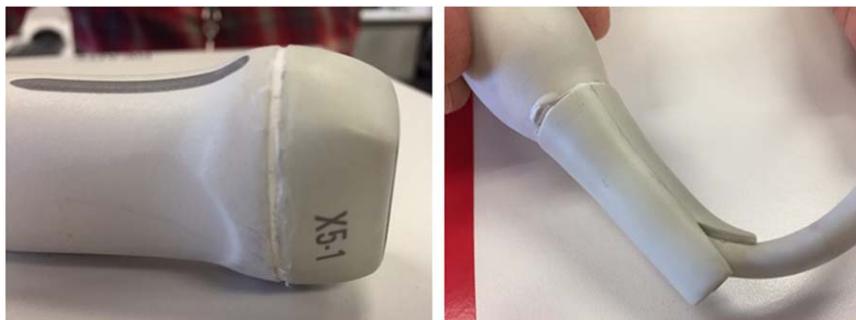
Figure 15. Poor-quality nose removal/reattachment with poor quality strain release.

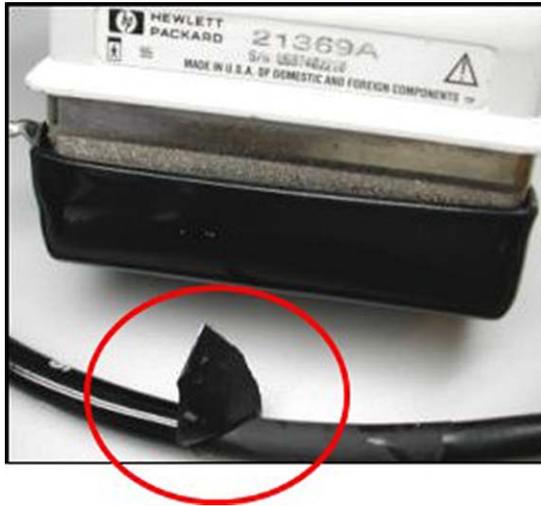
Figure 16. Use of nonbiocompatible materials on a TEE probe that came apart while in use.

Finally, poor-quality repairs are not limited to degradation of imaging performance. For example, Figure 16 shows a TEE probe repaired by using heat shrink material to cover the insertion tube. This material came apart while in use, and fragments were found in the patient's mouth on probe extraction, resulting in a substantial choking hazard to the patient.

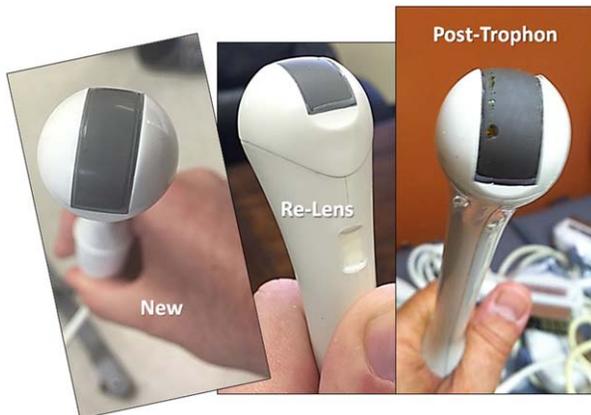
Figure 17. Use of different materials on a transvaginal probe eliminated the approved method of disinfection.

Figure 17 shows another example of improper material selection (non-OEM) for the replacement lens of an E8C-RS transvaginal probe (GE Healthcare,

Milwaukee, WI). Because of the validation testing performed by GE, the OEM probe can be safely cleaned with the Trophon disinfection system (Trophon EPR; Nanosonics Ltd, Lane Cove, New South Wales, Australia). However, when the repaired probe with different non-OEM lens material was used, the probe was damaged by the Trophon system. Therefore, a previously approved method of disinfection was no longer valid. Without proper cleansing, the risk of infection from cross contamination is substantial. It is also important to note that both the adhesion epoxies and lens materials require proper curing to be biocompatible. The FDA requires testing on any of these materials that are process dependent to confirm biocompatibility.
