Common Ultrasound Probe Failures

As Seen in Clinical Settings

G. Wayne Moore, B.Sc., MA, FASE, FAIUM
Acertara Acoustic Laboratories

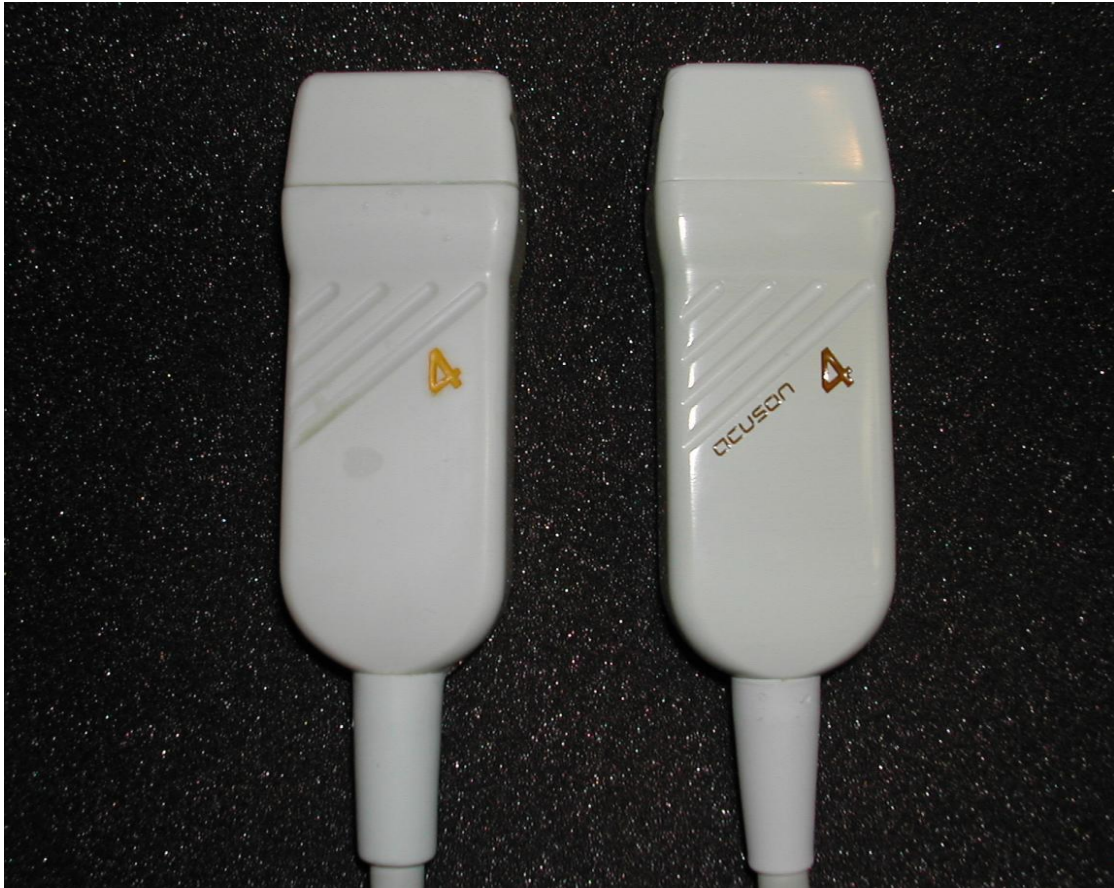
Counterfeit Probes

Another growing concern for ultrasound departments has been the illegal introduction of both counterfeit and misbranded probes into the after-market, general from over-sea manufacturers. These probes are made to appear like they are built by the Original Equipment Manufacturer (OEM), but have identifying marks that an observant sonographer can spot. As shown above the two probes are very similar in appearance. The probe on the left is the counterfeit as is distinguished by the different font color in the number 4, as well as the absence of the name of the manufacturer, in this case Acuson. There is a potential safety concern if using this probe relative to both the level of acoustic power being transmitted by the counterfeit as well as electrical leakage and material biocompatibility. There are now methods of testing these probes in the hospital to determine the authenticity of the probe. For example, if the hospital has an Aureon probe-testing device, it will also reveal acoustic performance variance between the counterfeit probe and an actual OEM probe. The Active-Z device will reveal electrical variances (e.g., changes in capacitance values) in performance between an OEM probe and a counterfeit.

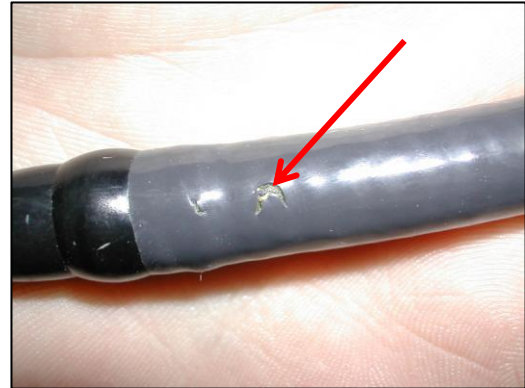
Transducer testing always starts with a thorough visual inspection of the probe patient contact points or wear-surface (e.g., lens, housing and cable). As the name implies, frequent use can wear or damage this surface, permitting caustic fluids, gels, or microorganisms admittance to the inner portions of the transducer. A simple illuminated 10x magnifying glass (Loupe) is required for this inspection. Transesophageal (TE) probes are especially susceptible to damage in and around the insertion tube sleeve and should receive close inspection for any bite or tooth drag marks (see Photo at right). Holes in the insertion tube sleeve will allow fluid ingress into the TE probe and can compromise patient safety and significantly damage the probe. Further, IAC (Intersocietal Accreditation Commission) requirements beginning in 2016 will mandate that a TE probe must have an electrical leakage test prior to every use.
