Acertara Technical Publications Series

A Guidebook for Diagnostic Ultrasound Probe Troubleshooting

Rev 1.5

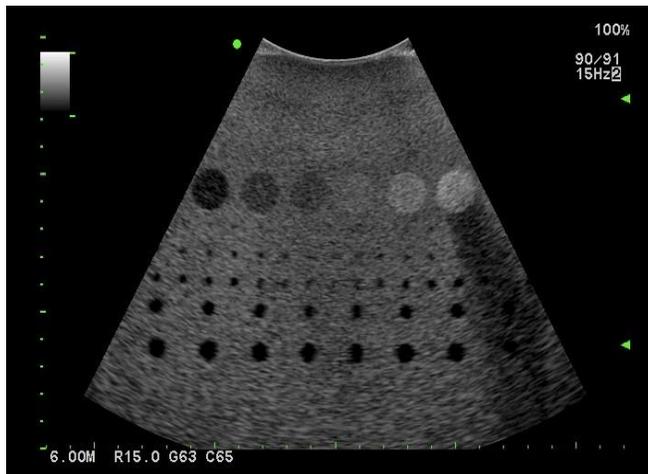
Cyst Simulation on TMP

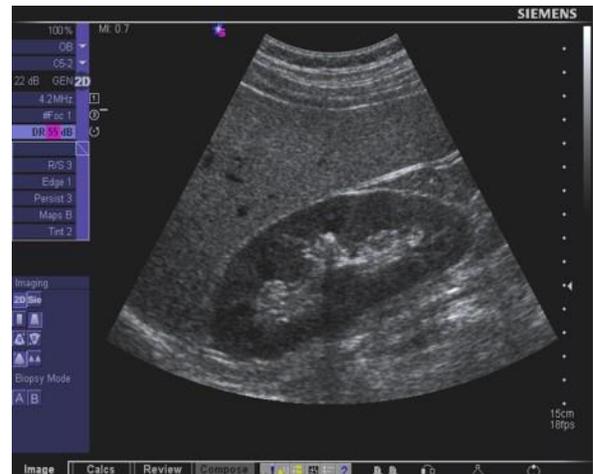
The other type of contrast resolution is related to tissue and the ability to distinguish echogenicity differences between neighboring soft-tissue regions, e.g., different types of tissue side-by-side, for example liver/kidney, liver/bowel, etc. The example below demonstrates this with a kidney/liver image

Tissue Contrast kidney/liver interface

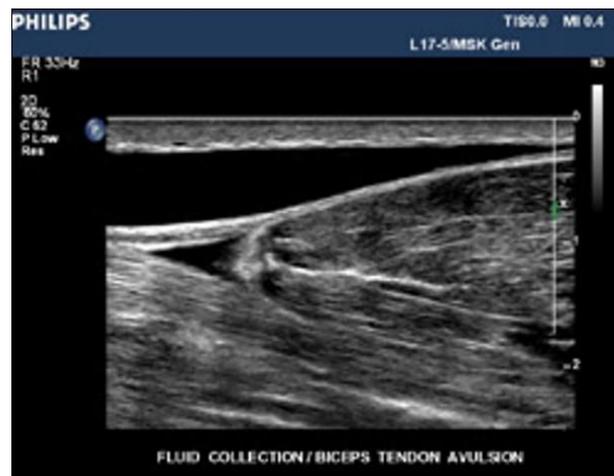
Anechoic Region/Tissue interface

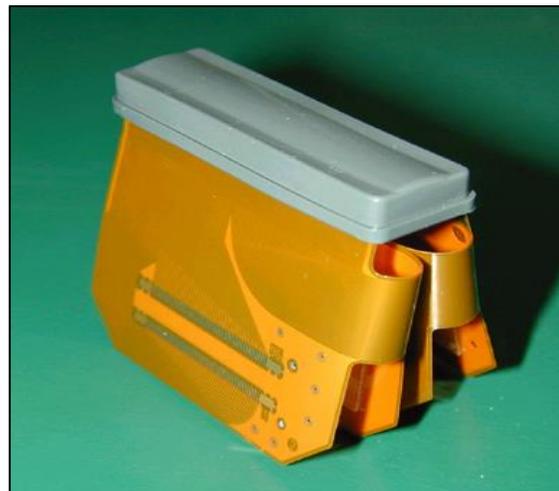
- 1) Flex circuit interconnect (shown below)
- 2) Acoustic stack (shown below)
- 3) Control electronics (not in all probes)

The most common issue with this component is lens delamination. This often occurs due to frequent cleaning with alcohol-based solutions which dries out the lens causing separation from the acoustic stack. Another frequent failure is cracks in the probe housing due to droppage. These need to be looked at very carefully with a 10x loupe (see following page) as they may present an HAI issue via cross-patient contamination.

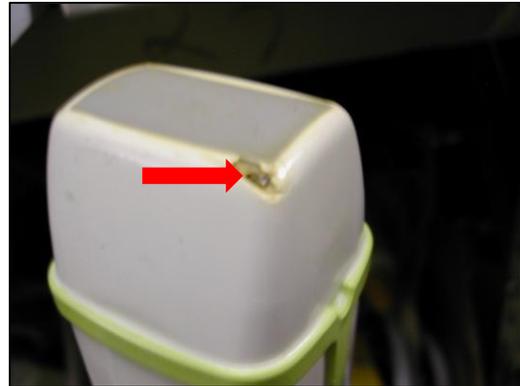
Crack in housing - HAI

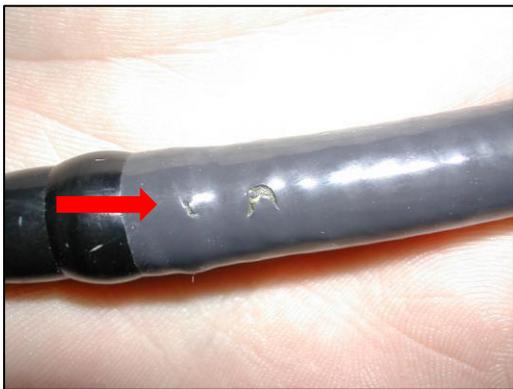
Teeth drag marks in TEE bending rubber
Fluid ingress risk and electrical leakage

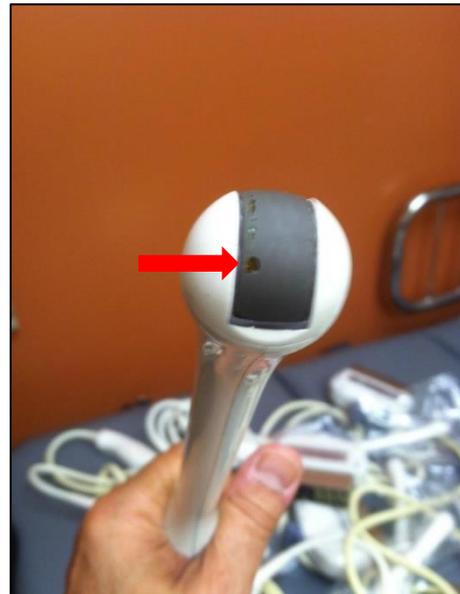
Lens damage – HAI and electrical leakage

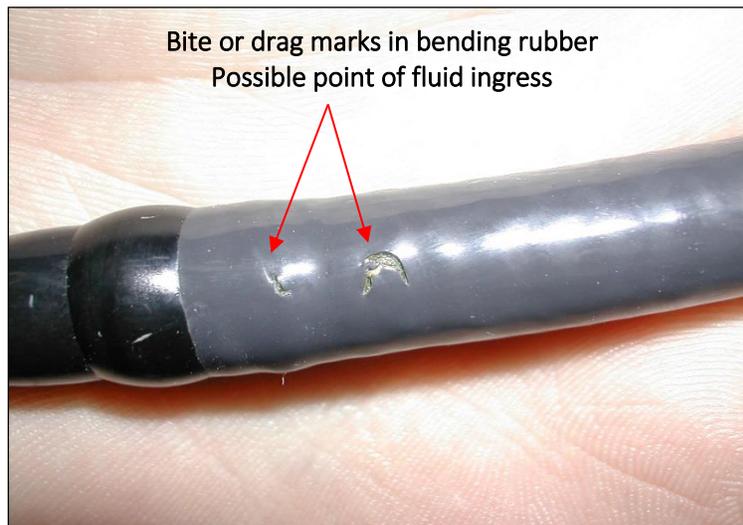
Philips X7-2t 2D Matrix Array TEE Probe

TEE Probe: TEE probes are designed to last a relatively long time (3 to 5 years), but only if the instructions for use, cleaning, storage, and testing outlined in the OEM's user manuals are followed. For example, the following language is from a GE TEE user guide: *"The expected service life of the 6VT-D probe is 5 years, provided the user follows the maintenance and care instructions on this card and in the user manual."* For example, when bite-guards are not consistently used, TEE probes are especially susceptible to damage to the bending area of the insertion tube (see Photo below), often allowing fluid ingress which can damage the various electronic components in the acoustic stack, shown below in the Philips X7-2t probe.

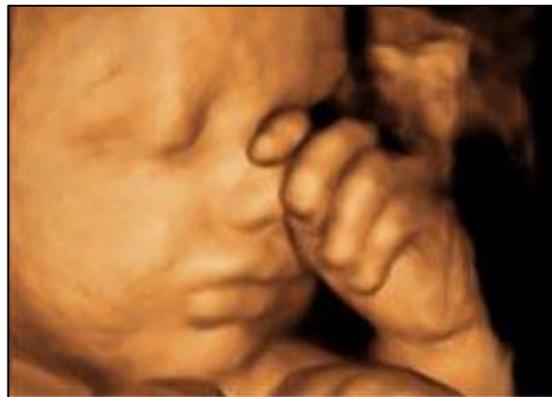
3D/4D Wobbler Probes

These probes are 1D curved and linear array probes that are swept mechanically through a predetermined arc (based on clinical application) via a stepper motor in an oil filled cap. The digital stepper motor links the 1D probe position with an acquired image. The image slices are then put together in the ultrasound system to form the 3D fetal image shown below. These probes are somewhat heavy and are often dropped. Lens damage and oil leakage are two of the main problems from trauma. The internal step motor and the Hall-effect devices are also a common source of failure, in this case the system will either stop the probe from trying to initialize, or the probe will try and start giving a slight jerky feeling while it is held in your hand. These types of failures are repairable.

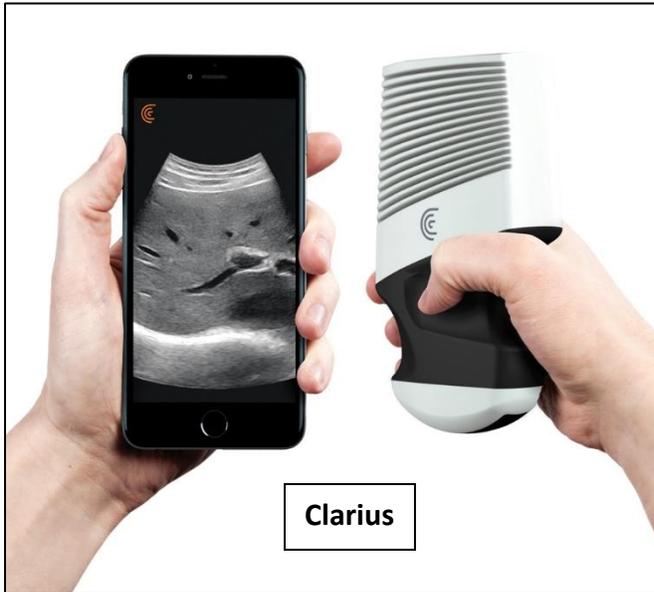
Aureon is an important testing tool for the newest probe/smart phone devices currently on the market, specifically the hand-held devices such as the Butterfly unit shown below, as well as wireless devices such as the Clarius unit, also shown below.
